ThermalScope

OCCUPATIONAL HEALTH & SAFETY
AND PREVENTATIVE MAINTENANCE INSPECTION

ELECTRICAL DISTRIBUTION BOARDS & NOMINATED EQUIPMENT

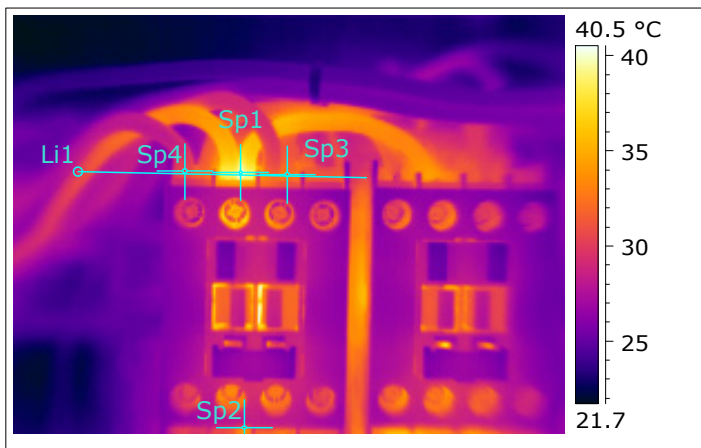
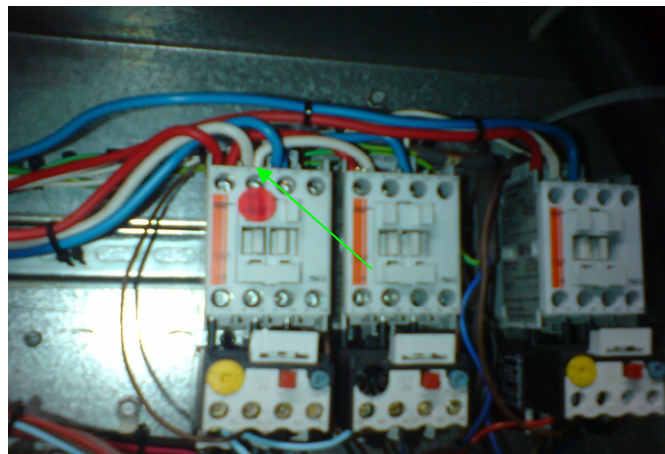
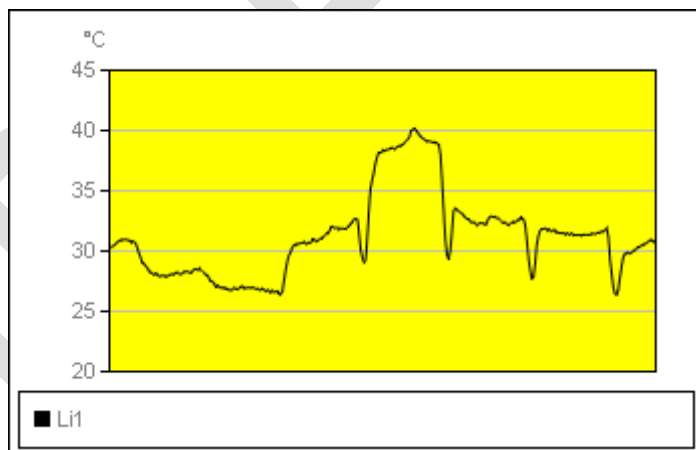
REP No'
1

Area Chiller Plant Room
Equipment Chiller 1 – Condenser Fan
Device Contactor

Sp1 Temperature	40.0 °C
Sp2 Temperature	33.4 °C
Sp3 Temperature	32.3 °C
Sp4 Temperature	30.7 °C

PRIORITY	
3	
RECOMMENDATION	MAINTENANCE

Initial overheating at termination.
 Check termination.
 Check load conditions.

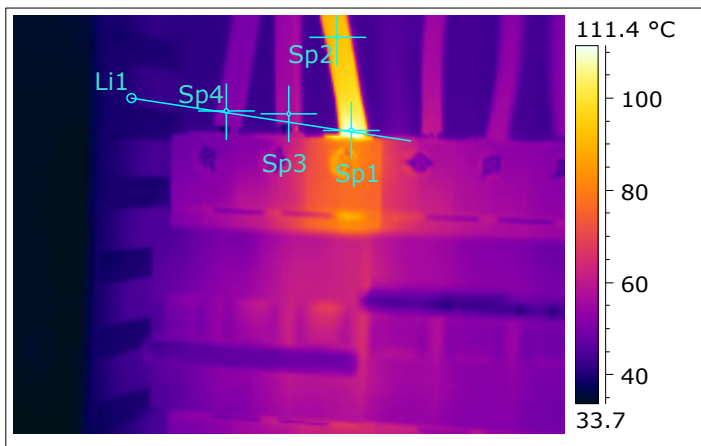
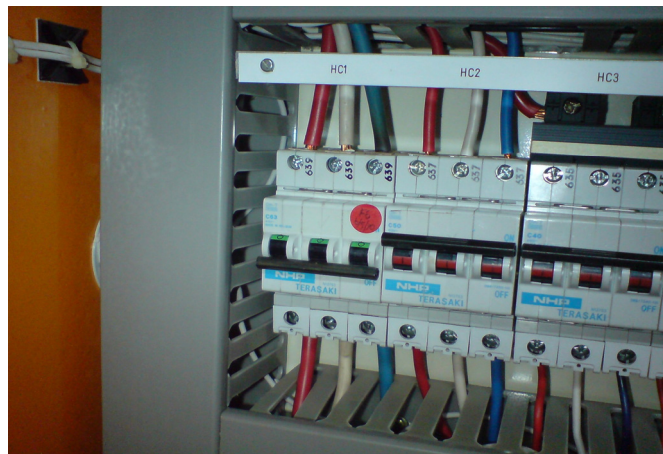
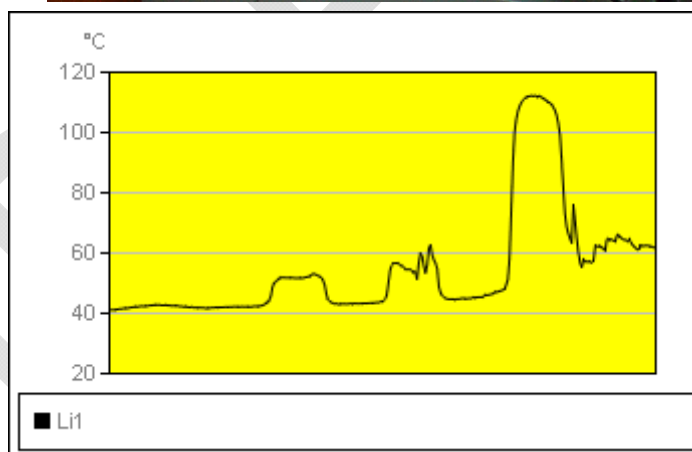
REP No'
2

Area | Top Plant Room
Equipment | MCC 2B
Device | Circuit Breaker – HC 1

Sp1 Temperature	111.6 °C
Sp2 Temperature	93.1 °C
Sp3 Temperature	57.1 °C
Sp4 Temperature	51.7 °C

PRIORITY	
1	
RECOMMENDATION	URGENT

Established overheating at termination.
Priority level upgraded due to fault condition exceeding V75 thermal limits of cable.
Check termination.
Check load conditions.
Visible damage evident on cable.

*Circuit Breaker HC 1 was switched off electrical staff when this fault was found.

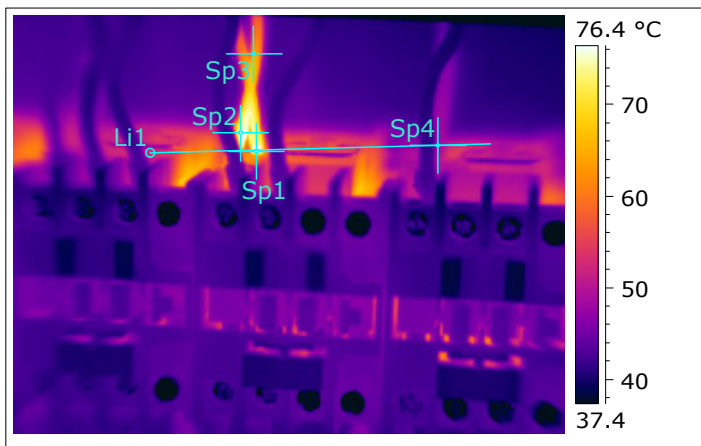
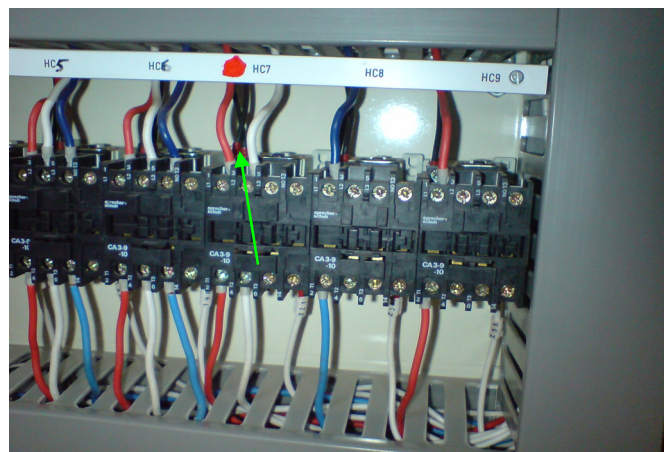
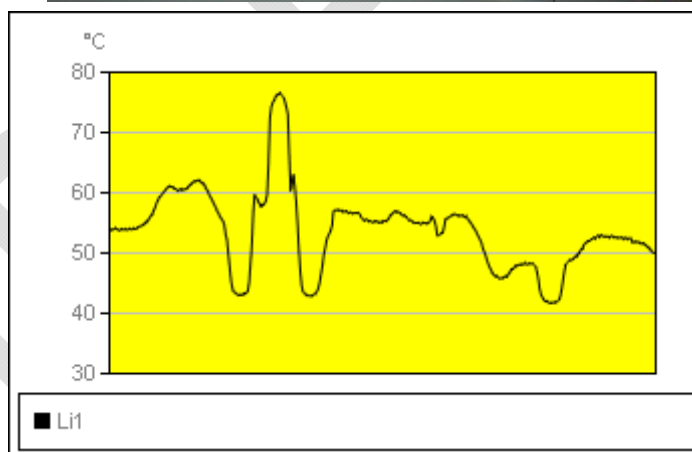
REP No'
3

Area Main Plant Room
Equipment MCC 2B
Device Contactor – HC 7

Sp1 Temperature	76.5 °C
Sp2 Temperature	76.3 °C
Sp3 Temperature	64.4 °C
Sp4 Temperature	48.8 °C

PRIORITY	
1	
RECOMMENDATION	URGENT

Established overheating at termination on top side of coil.
Priority level upgraded due to fault condition exceeding V75 thermal limits of cable.
Check termination.
Check bootlace crimp connections.
Check for heat damage to cable.

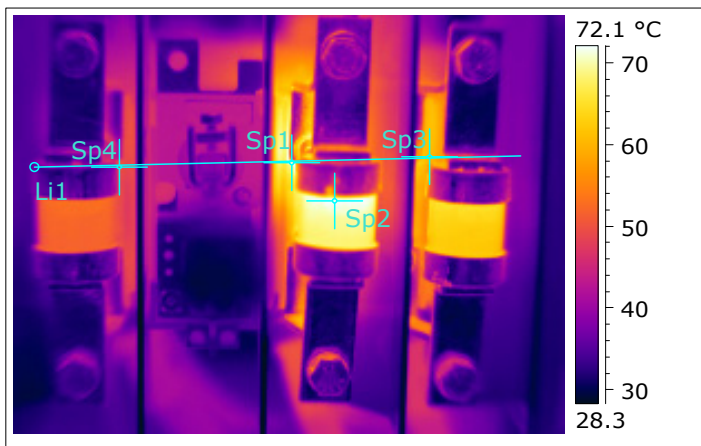
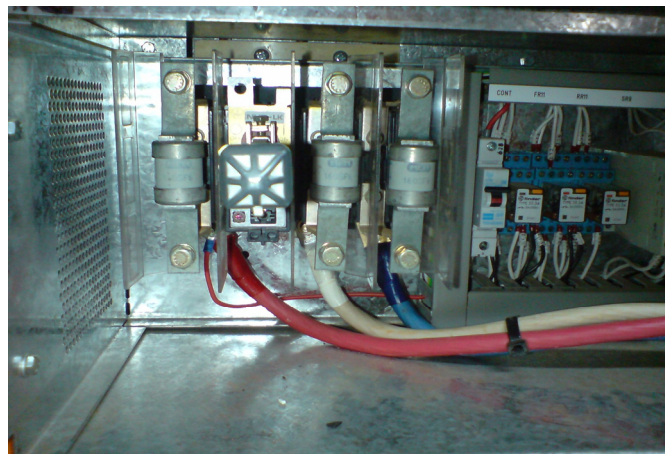
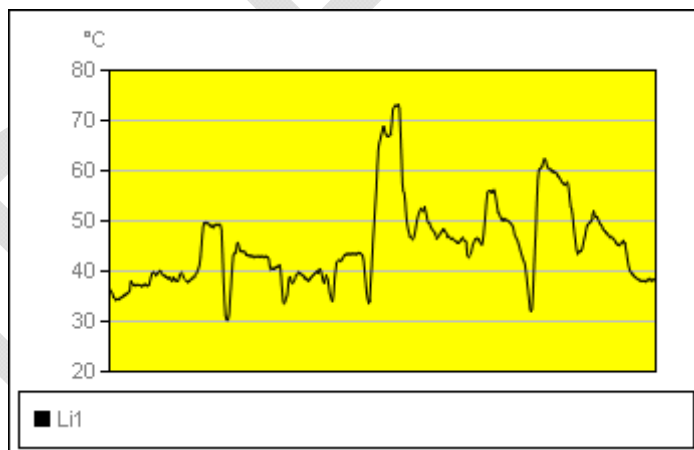
REP No'
4

Area Main Plant Room
Equipment MCC 2A
Device CFS – Fan 2

Sp1 Temperature	73.0 °C
Sp2 Temperature	72.0 °C
Sp3 Temperature	60.0 °C
Sp4 Temperature	49.6 °C

PRIORITY	
1	
RECOMMENDATION	URGENT

Established overheating at termination.
Priority level upgraded due to line side fault conditions.
Check load conditions on circuit.
Check connection of fuse.
Check connections of mounting chassis for fuse system.
Check condition of fuse.
